Manhole Inspection Summary

Manhole # S43A__017MH

Insp Date: **4/19/08 9:06 AM**

Location Address: **Orleans St**

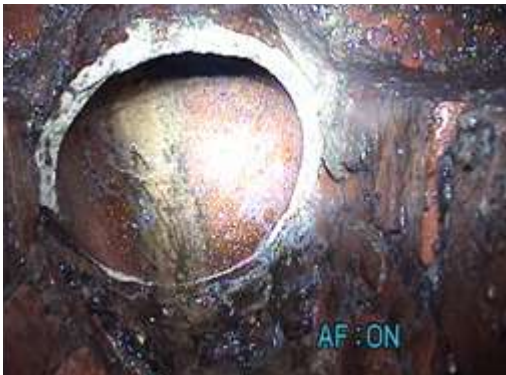
capped 3 oclock

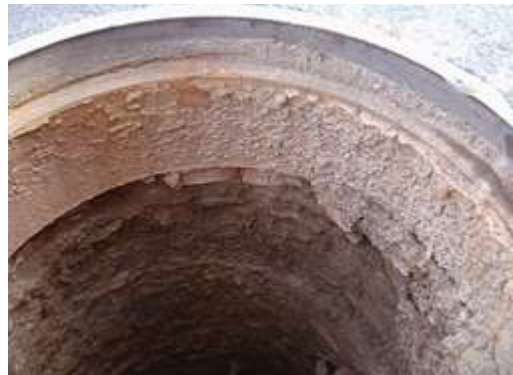
Defect 2

☒ **Leaks**

Frame Leaks

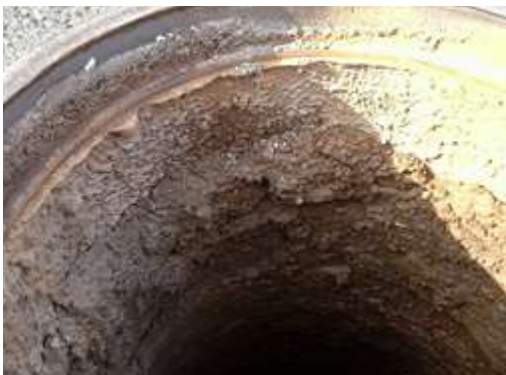
Defect 1

Infiltration: ☐ None ☐ Joint ☐ Cracks ☐ Mortar ☐ Roots ☒ **Wall**

Infiltration

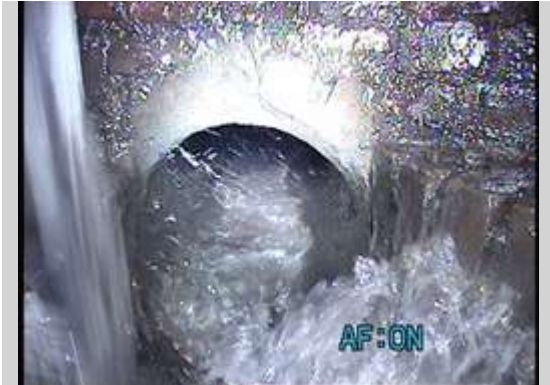
12 O'Clock Outflow

12 in. Circular Gravity Sewer
Pipe Out @ 12 O'Clock

Pipe Height: **12** (in.) Rod and Bar (Angled)
Pipe Material: **Clay** ☐ Pipe Lined
Invert Depth: **12.00** (ft.) Flow Characteristics: **Fast**
Deposits: ☒ None ☐ Mud ☐ Sludge ☐ Debris ☐ Grease
Silt Depth: (in.) Deposits Extent:
Infiltration: **None** Pipe Seal Cond: **Sound**

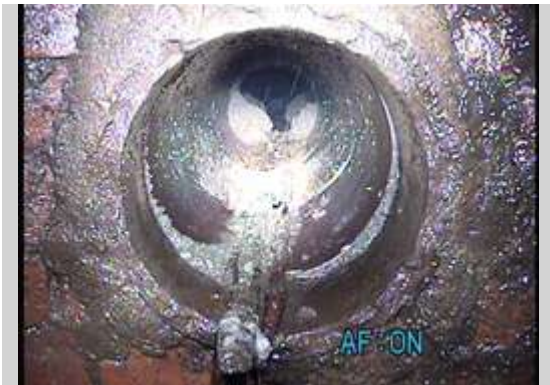
3 O'Clock Inflow

8 in. Circular Gravity Sewer
Pipe In @ 3 O'Clock

Pipe Height: **8.4** (in.) Rod and Bar (Angled)
Pipe Material: **Clay** ☐ Pipe Lined
Invert Depth: **9.80** (ft.) Flow Characteristics: **Fast**
Deposits: ☒ None ☐ Mud ☐ Sludge ☐ Debris ☐ Grease
Silt Depth: (in.) Deposits Extent:
Infiltration: **None** Pipe Seal Cond: **Sound**

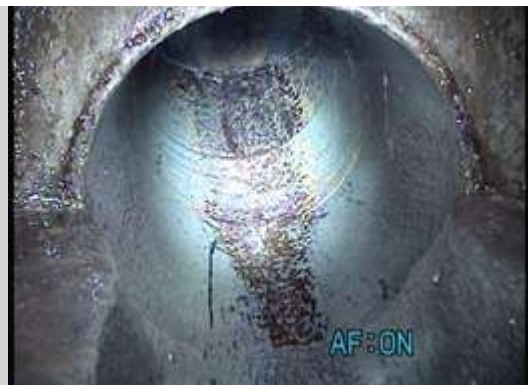
6 O'Clock Inflow

8 in. Circular Gravity Sewer

Pipe In @ 6 O'Clock

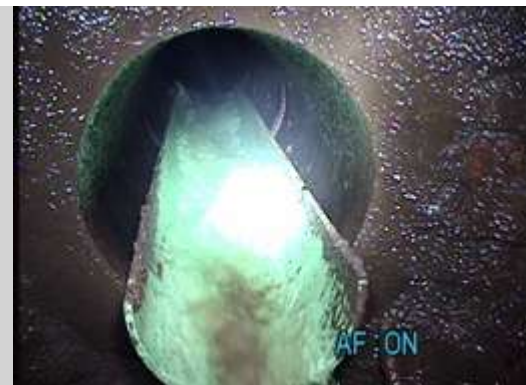
Drop In @ 6 O'Clock

Debris in Drop.

Drop: **Inside** Rod and Bar

Drop Condition: **Open**
